URGENT SAFETY ADVICE- PLEASE READ CAREFULLY

21/1/08

SB080122 – High rise stabiliser leg cylinder transfer tube excessive movement

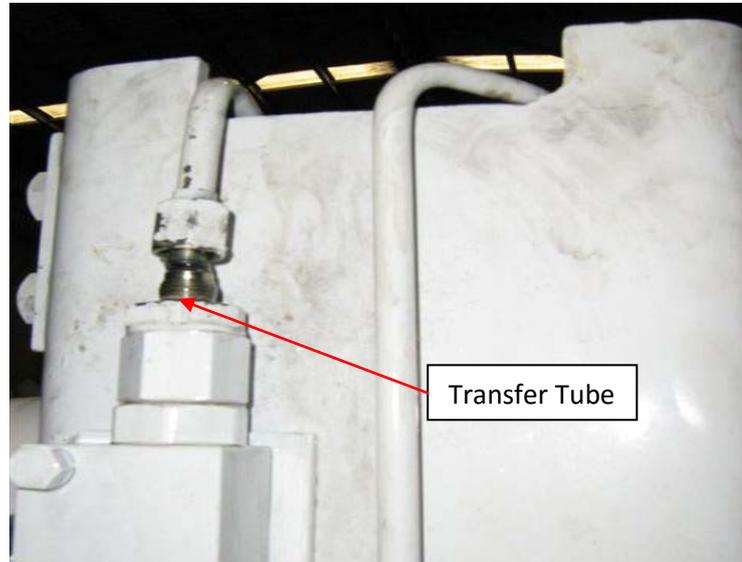
Figure 1

Excessive clearance between the cylinders clevis and the mounting plates may result in accelerated fatigue in the tube connections and could increase the potential to generate cracks on the transfer tube. In the event of a hydraulic transfer tube failure the cylinder will not hold the weight of the EWP.

1. Ensure that there are no apparent cracks or damage on transfer tubes on all front stabiliser legs on LLF16.350 models. (As per figure 1).

GMJ Equipment recommends you remove the affected units from service immediately until visual inspection is carried out as described below.

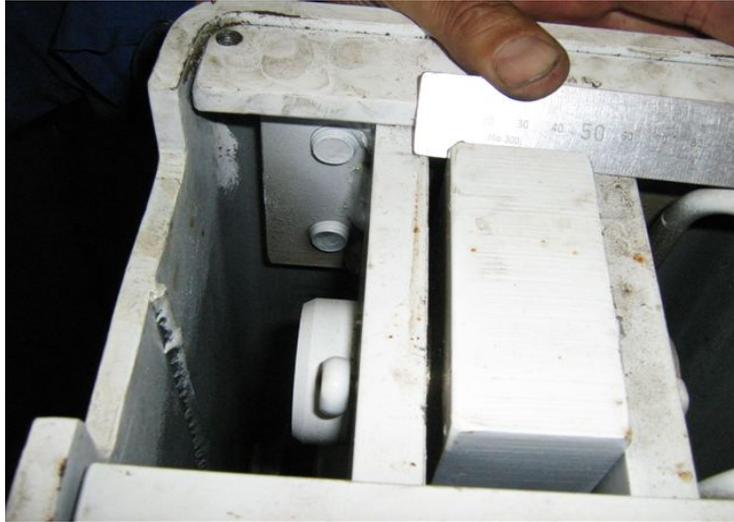
2. Measure the total clearance between the clevis end of the vertical (up & down) cylinder and the two mounting plates, as shown in figures 2a. and 2b. if this clearance is greater than 1.5mm, it could increase the potential to generate cracks in the transfer tube. The total clearance is measured by moving the cylinder to one side against one mounting plate and measuring the gap between the opposite plate and the clevis.

Figure 2a - Clearance between cylinder clevis end and mounting plates.

If the total clearance exceeds 1.5mm, or there are signs of cracks in the tube or connections, withdraw the unit from service.

If the total clearance is less than 1.5mm, the unit may return to service.

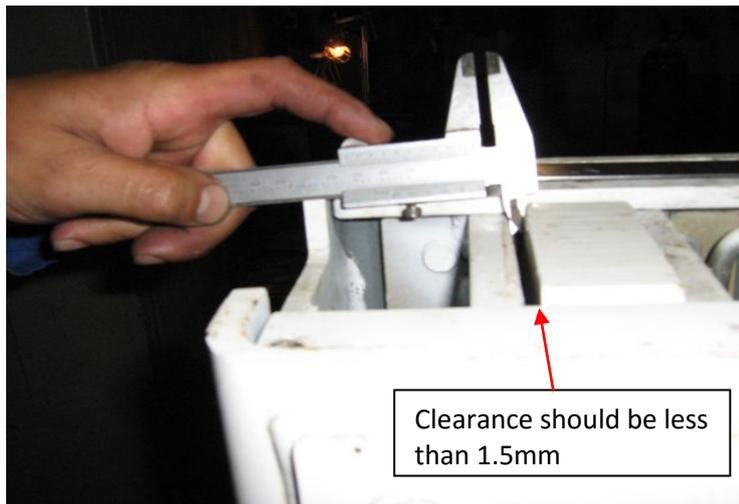
Figure 2b: Clearance between cylinder clevis end and mounting plates. (Should not exceed 1.5mm)
