## SAFETY ALERT

**Safety advice:** SB161207  
**Subject:** Pin retainer inspection on GMJ Model LL18-650/s MEWP compensating link assembly

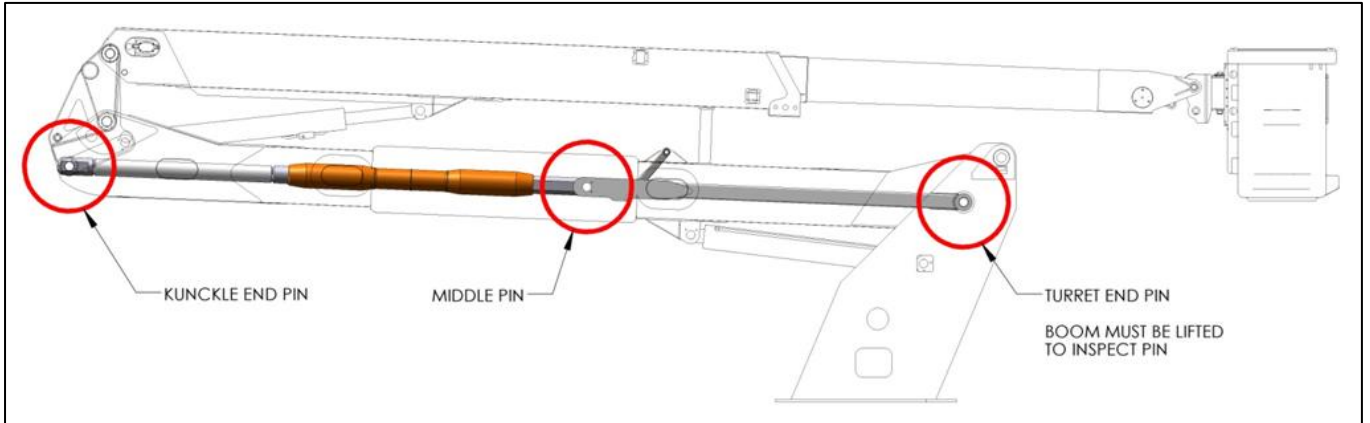
Diagram 1

Initial reports have indicated that the possible failure was caused by the pin located at the knuckle end of the compensating link assembly becoming dislodged. The effected unit and circumstances are still under investigation by SafeWork SA and SA Power Networks.

Inspect all retaining pin bolts on the compensating link assembly as detailed in diagram 1 for security and tension. If tension is as per specification - M10 bolt (45Nm) or M12 bolt (80Nm), apply witness marking to the bolt for future reference.

If during the inspection it is found that a bolt appears to be coming adrift, perform the following rectification:

- a) Remove the bolt
- b) Apply thread locker (Loctite)
- c) Fit bolt/washers and tension bolt
- d) Torque bolt – **M10 bolt (45Nm) or M12 bolt (80Nm)**
- e) Witness mark retaining bolt once satisfied the bolt is correctly secured and torqued

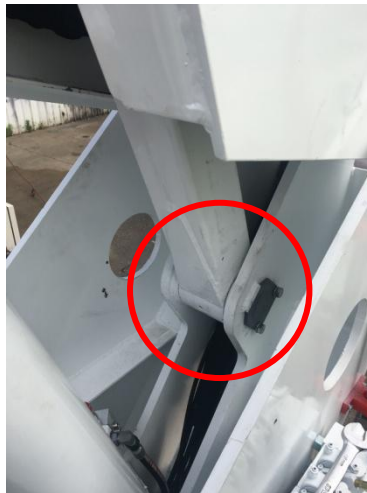
### A: Turret end pin inspection

4. Visually inspect the pin retaining bolts & circlip and check the bolt for tension.
5. If a bolt is coming adrift, perform the rectification procedure as described on page one of this document.

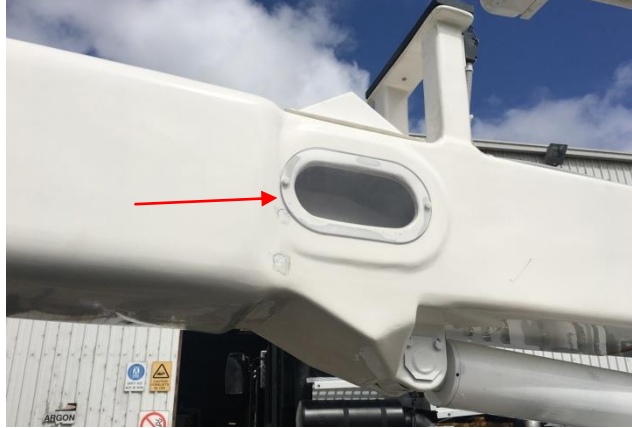
### **B: Middle pin inspection**

7. Visually inspect the pin retaining bolts & circlip/split pin and check the bolt for tension. A mirror may be required to perform a thorough visual inspection.
8. If a bolt is coming adrift, perform the rectification procedure as described on page one of this document.

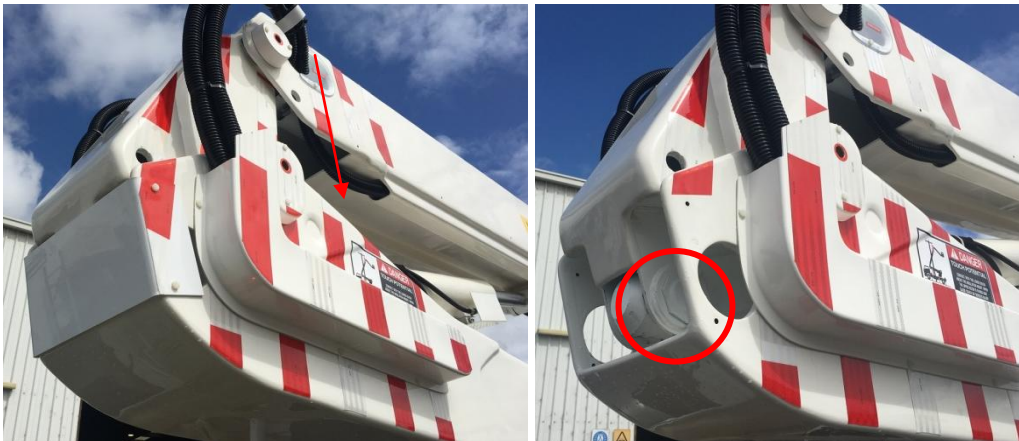
### **C: Knuckle end pin inspection**

10. Visually inspect the pin retaining bolts & circlip and check the bolt for tension.
11. If a bolt is coming adrift, perform the rectification procedure as described on page one of this document.
